# Flood Investigation Report

Location of Investigation: Capel-le-Ferne

Date of incident: 04-05 November 2023

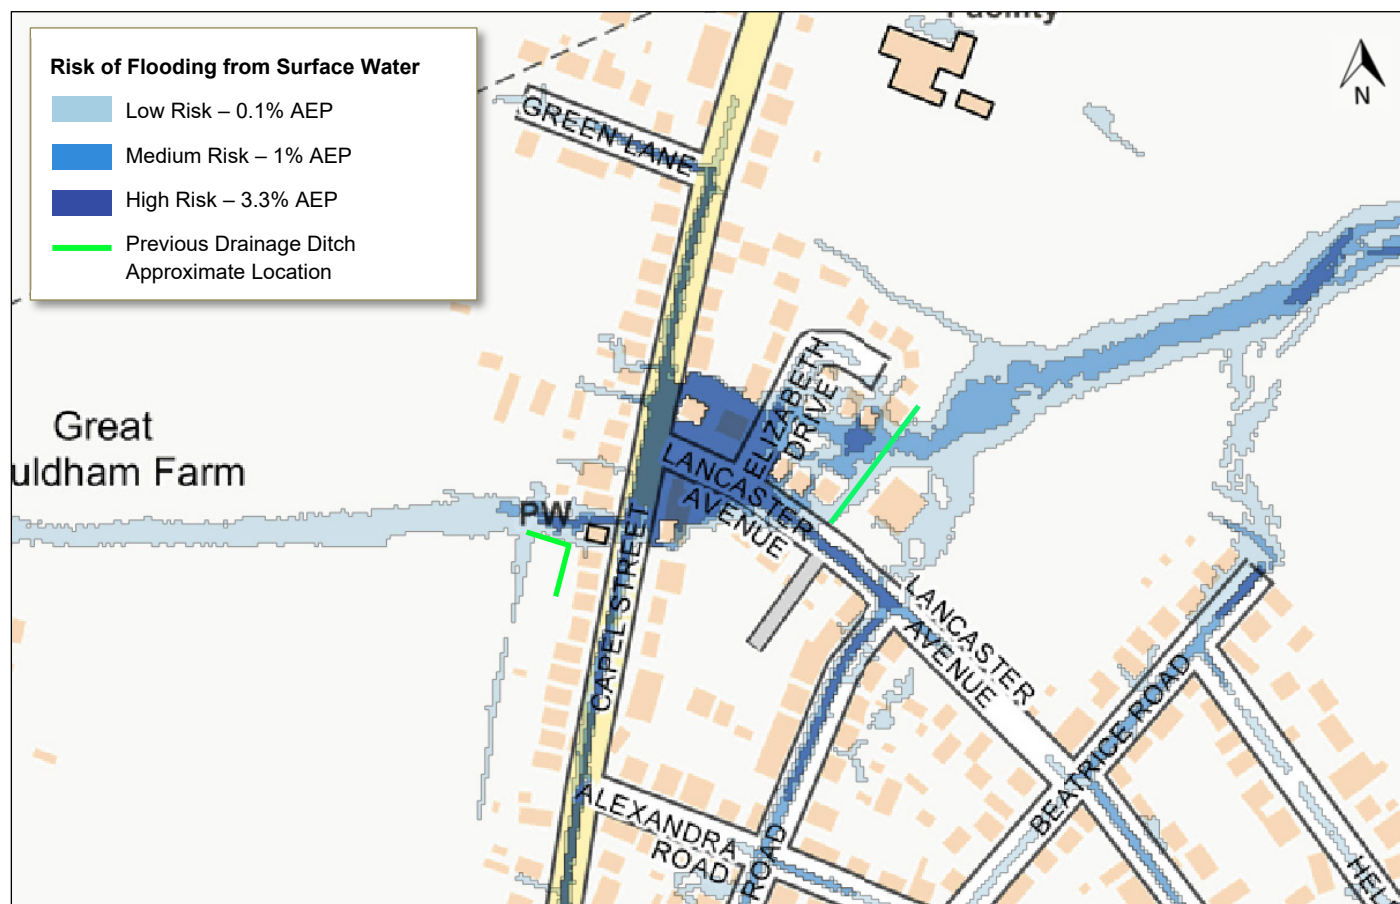
The primary source of flooding is considered to be surface water (overland flow). The Environment Agency’s (EA’s) ‘Flood Risk from Surface Water’ map (Figure 1) indicates there is a natural surface water overland flow path which flows in a predominantly west to east direction, from the direction of Great Cauldham Farm, across the agricultural field, to the junction at Capel Street and Lancaster Avenue. There is an additional, larger surface water overland flow path which flows predominantly northeast to southwest, from Dawkinge Wood towards the Junction between Capel Street and Lancaster Avenue, before continuing northeast towards Dover.

Post the 2007 flood event two drainage ditches in the area have been removed. One drainage ditch ran along the border of the agricultural field and adjacent to the residential properties, delineated in green in Figure 1 below, this is believed to have been a blind ditch at the boundary of the field, this ditch has become infilled with material including concrete blocks and sediment. A second drainage ditch adjacent to the footpath by the village hall, is also delineated in green in Figure 1 below was infilled and replaced with soakaways and a perforated pipe (installed as a solid length of pipe) during the works carried out to improve the drainage system in the area post the 2007 flood event.

Flooding from surface water is typically associated with natural overland flow paths and local depressions in topography where surface water runoff can accumulate during or following heavy rainfall events. The EA's 'Flood Risk from Surface Water' map and aerial height data shows a topographic depression at the junction of Capel Street and Lancaster Avenue, resulting in a 'high' risk area. The areas indicated to be at high risk of flooding from surface water sources are relatively consistent with the locations of reported properties affected by the flood event.

Figure 1 – EA's 'Flood Risk from Surface Water' map (© Environment Agency. Contains Ordnance Survey data © Crown copyright and database right 2024). An extract of this mapping for the wider area is included within Annex 2.

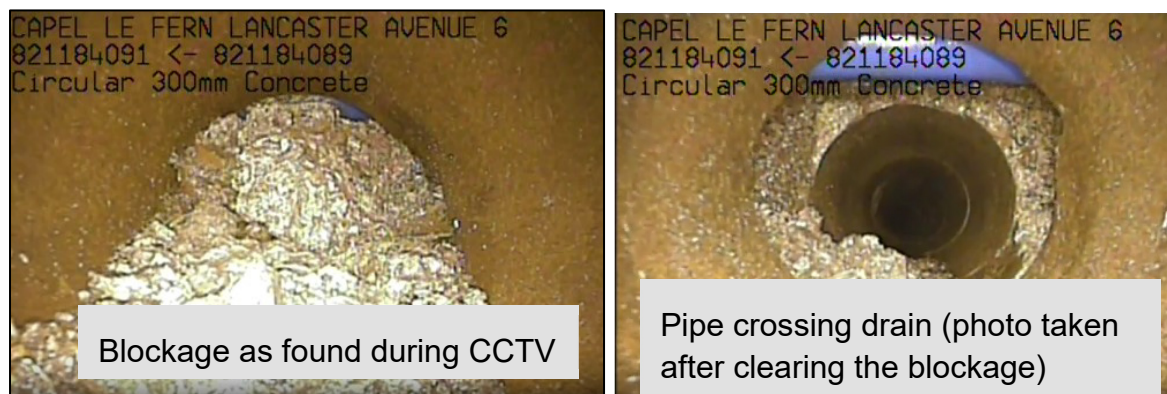
During the flood event, it is likely that this network was blocked due to a combination of factors, such as, a water main which crosses the pipe (third party damage due to subsequent installation of water main) and general debris. The location of this blockage was downstream of the flooding at the junction between Capel Street and Elizabeth Drive.

*Figure 2 – Blockage at the junction of Capel Street and Elizabeth Drive.*

The blockage in this network prevented the connected gullies from draining floodwater away from the area during the flood event. Gullies to the east of the blockage, at the entrance to Elizabeth Drive, would have been located beyond this blockage and consequently, may have allowed water to drain away from the area. The presence of the gullies located beyond the blockage potentially limited the depth and extent of the flooding witnessed, i.e., once the flood extent/depth had reached a point where water could enter the unblocked drainage network.

- An assessment of the existing drainage system should be carried out .,where defects are found in the existing drainage system these should be repaired, or if necessary, parts of the existing drainage network replaced.

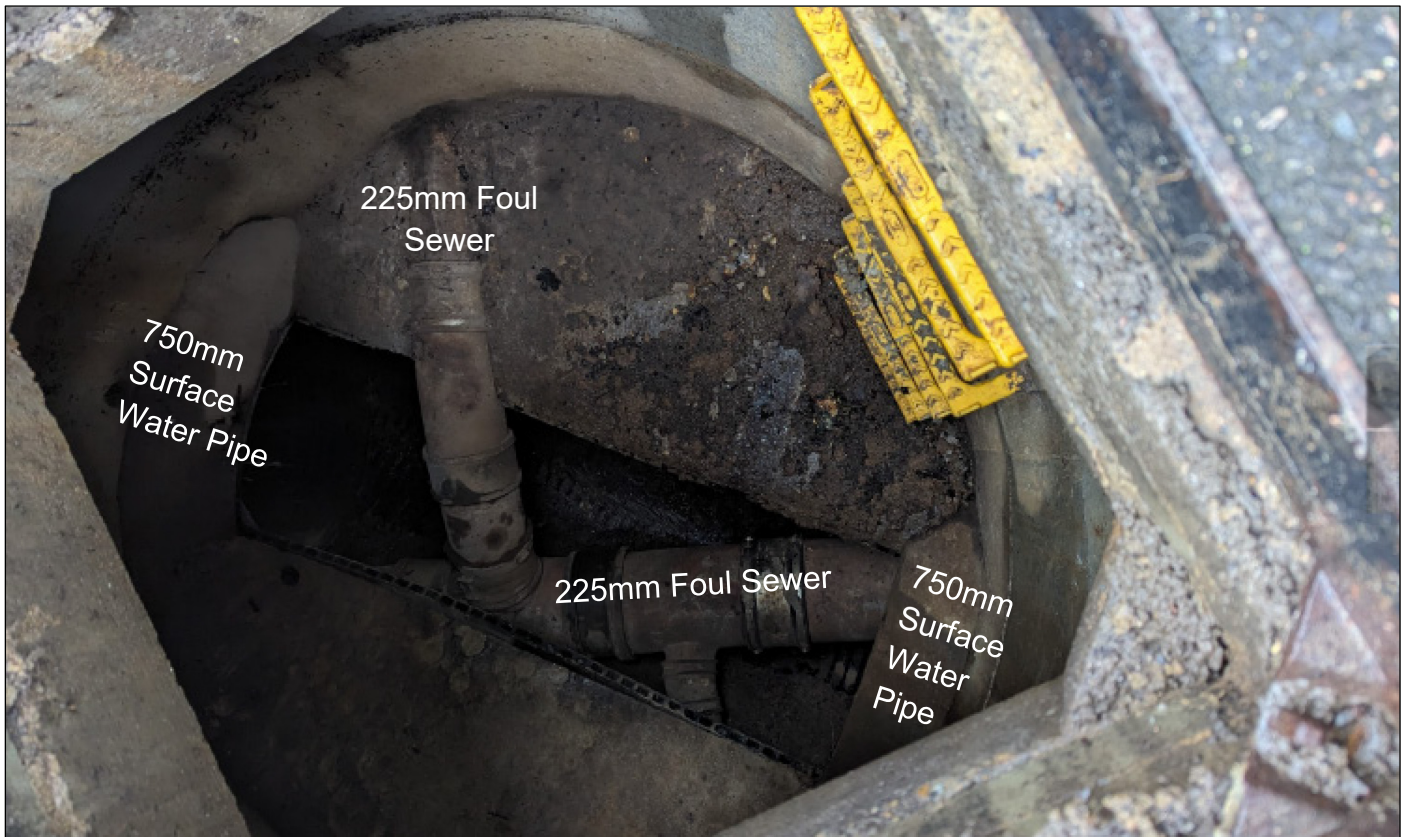
The hydraulic performance of the 750mm diameter pipe is impacted by an obstruction, (a foul sewer which passes through and blocks a significant part of the surface water pipe). This obstruction is shown in Figure 3 below.

Figure 3 – Significant obstruction to flow and area considered likely to be prone to blockages.

This section of the drainage network would be extremely prone to blockages, as mud or other debris could get lodged on the underside of the pipe. A blockage at this location may have contributed to the flooding on the 04 and 05 November 2023, by preventing floodwater from draining away via the high-capacity gullies.

A blockage at this location could have also prevented water from draining away via the overflow connection that exists between the northern Caple Street network and the flood alleviation network.

This mechanism of flooding (via a blockage) is supported by observations made by residents, who stated that the road gullies were not draining the water away. Notwithstanding these accounts, even in the absence of a blockage, the obstruction in the pipe is likely to have been sufficient to restrict the flow of water away from the area, which could have contributed to the flooding witnessed.

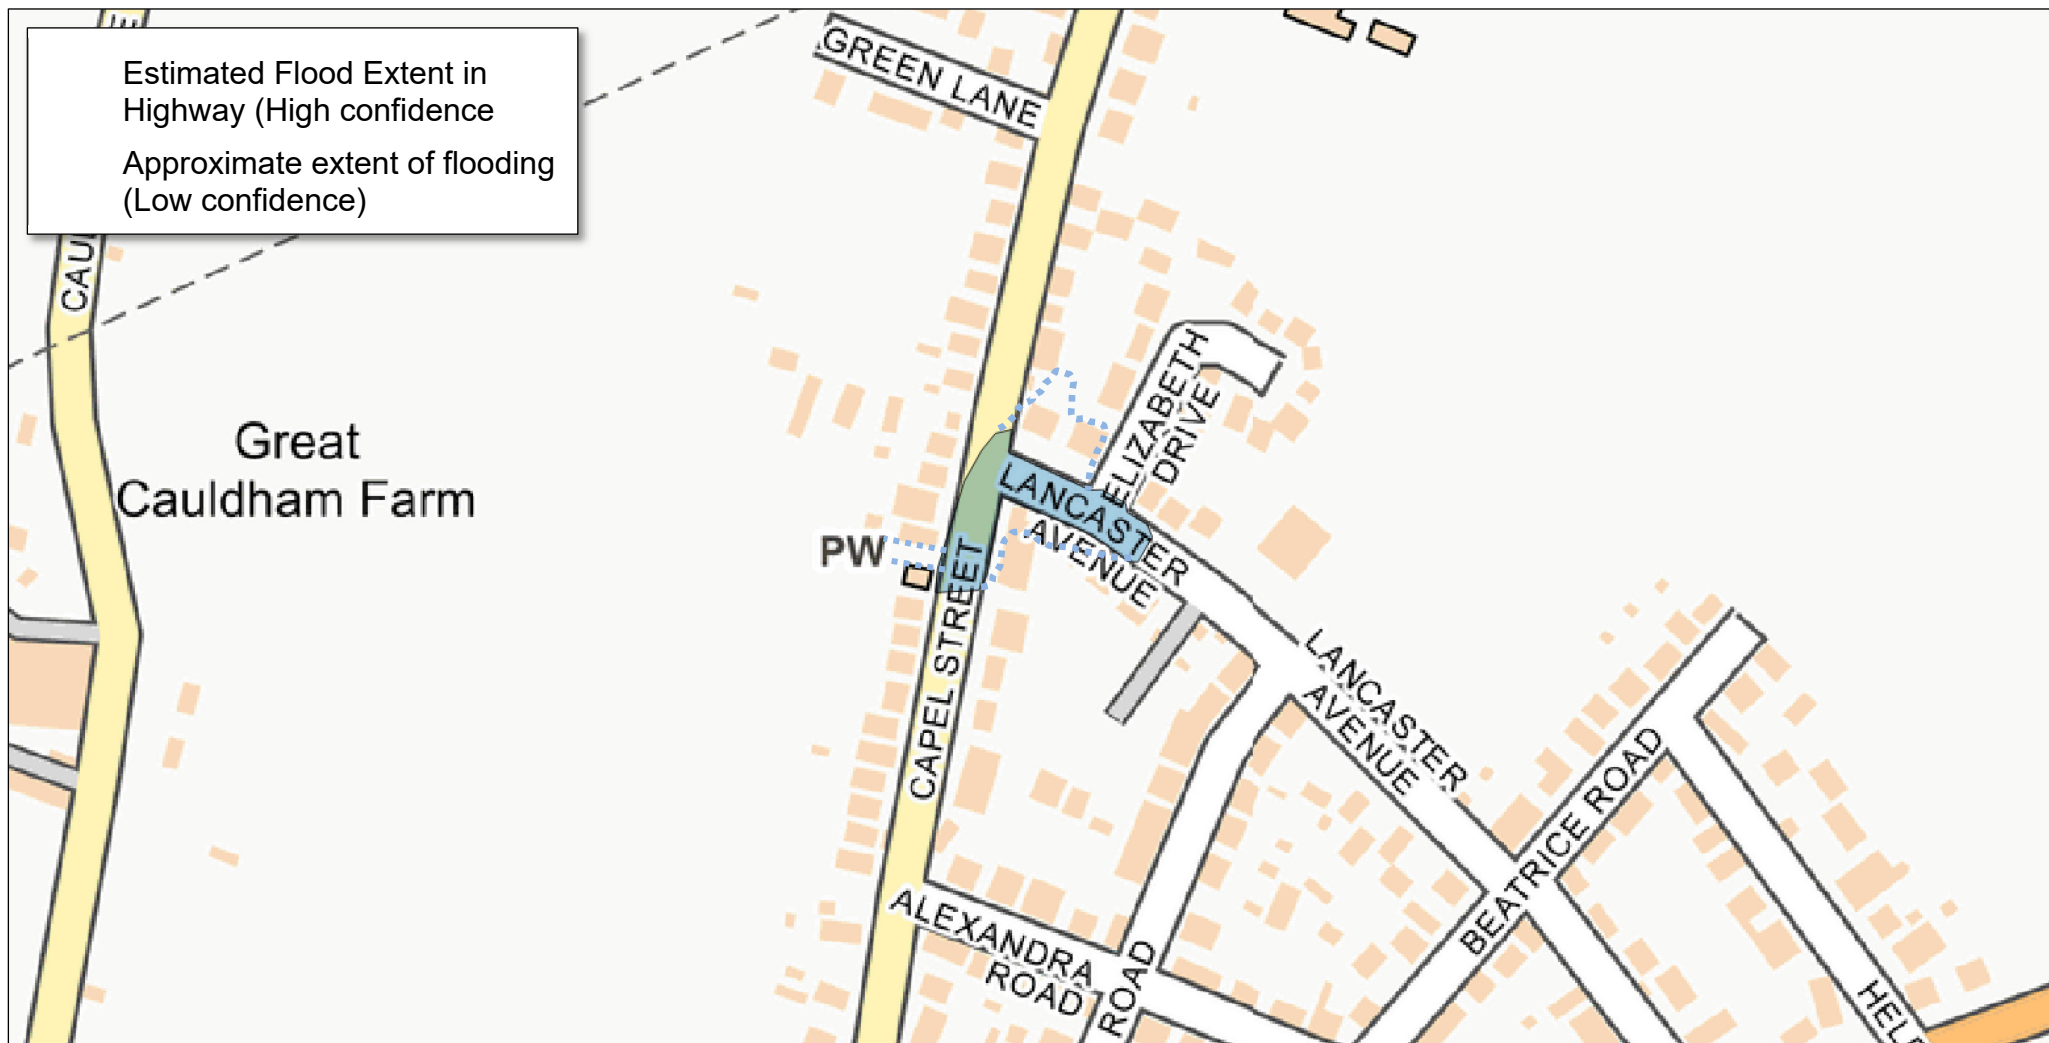
Annex 1 – Estimated flood extent of reported flood incident in Capel-le-Ferne. The estimated flood extent covers the roads only and not the properties which experienced flooding.
