Culvert Replacement

Catts Place, Tonbridge

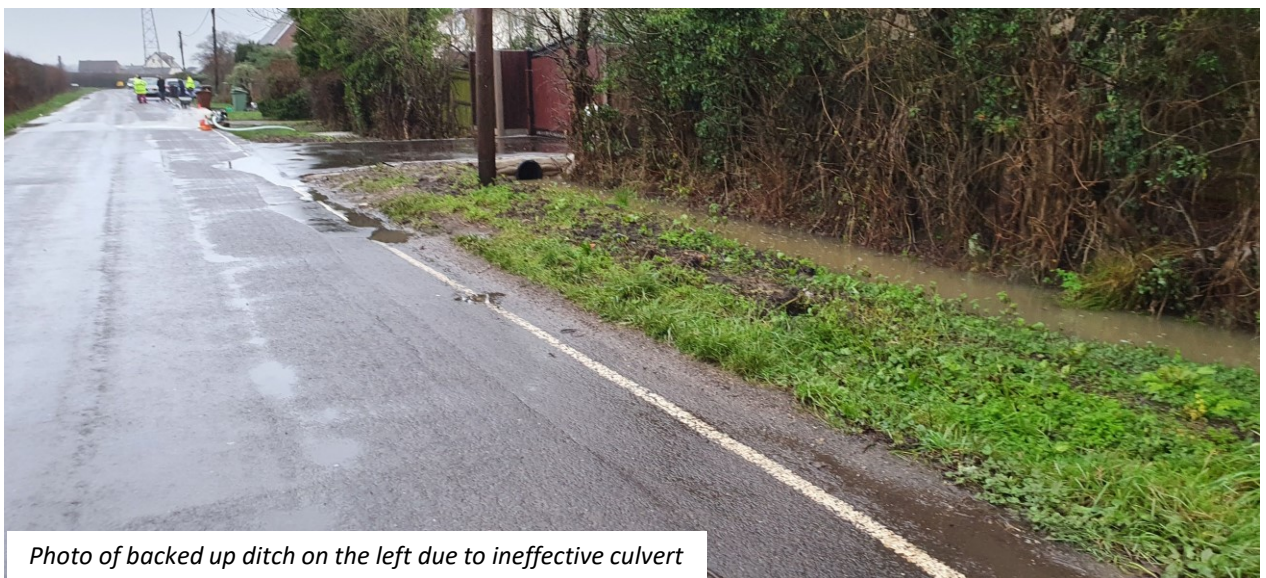
Between 2014 and 2021, Catts Place residents and highway in Paddock Wood, experienced 20 incidents of flooding. The poor condition of the culvert caused the floods. It's length, at over 100 m, and lack of access points made it difficult to maintain using the standard equipment for pipe clearance. It was also in poor condition, with displaced joints that meant blockages were likely to reoccur even if they were removed.

Photo of backed up ditch on the left due to ineffective culvert

Working closely with residents, the Flood and Water Management Team assessed options to replace the culvert, reduce flood risk and improve the maintainability of the system. The preferred scheme replaced the long culvert with a culvert in three sections, with access at approximately every 30 m, which will allow access for maintenance and allow overpumping if further blockages do occur.

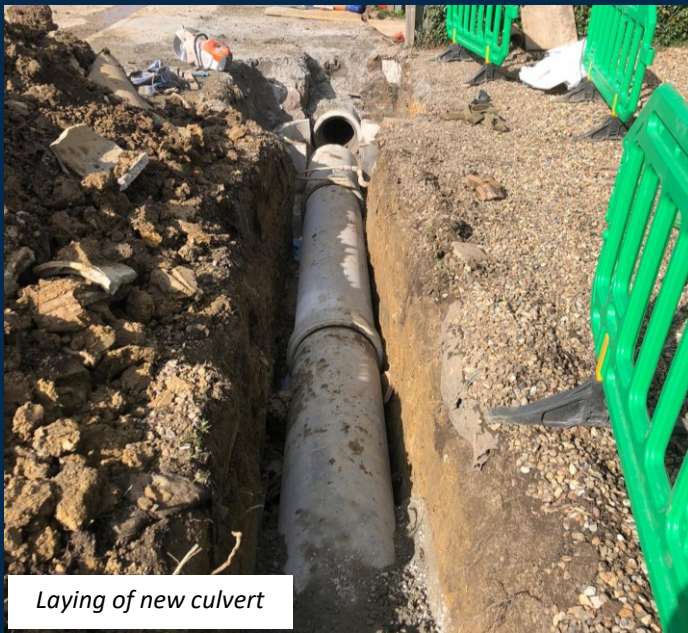
Laying of new culvert

The culvert is located under driveways, garden walls, and vegetation at the front of the resident's gardens and between the services and utilities serving the properties. The new culvert was installed with the minimum of disruption.

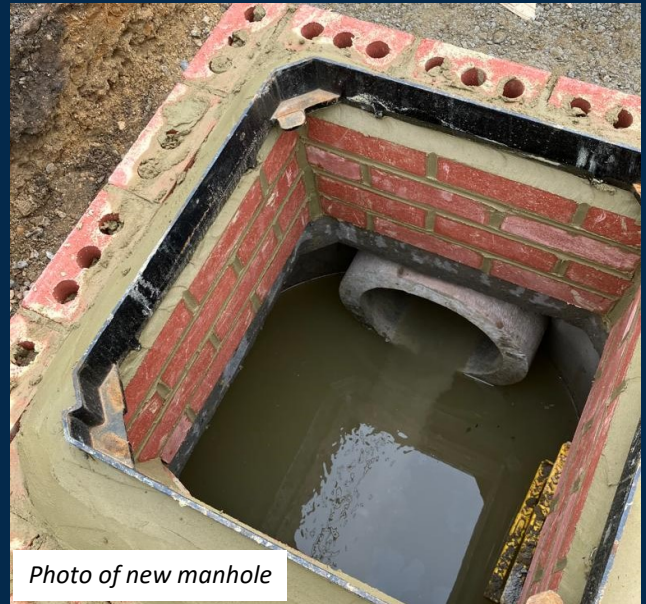
Photo of new manhole

Three manhole chambers were installed to add capacity and aid future maintenance and repair work by landowners. It also allows standard jetting equipment to be used as the length of culverted sections is reduced.

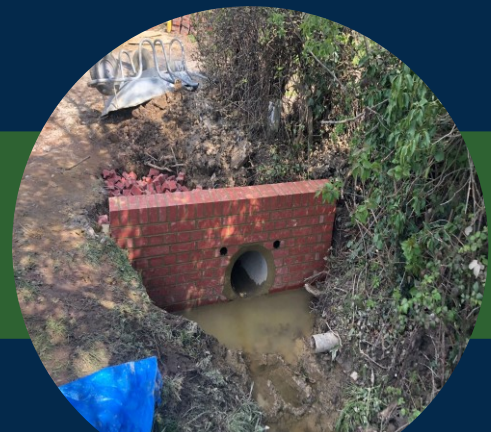
Headwall at the end of the culvert
